Newcrest Mining Bund Remedial Works

Telfer, WA

CUSTOMER Newcrest Mining
 SECTOR Mining
 DATE 2022

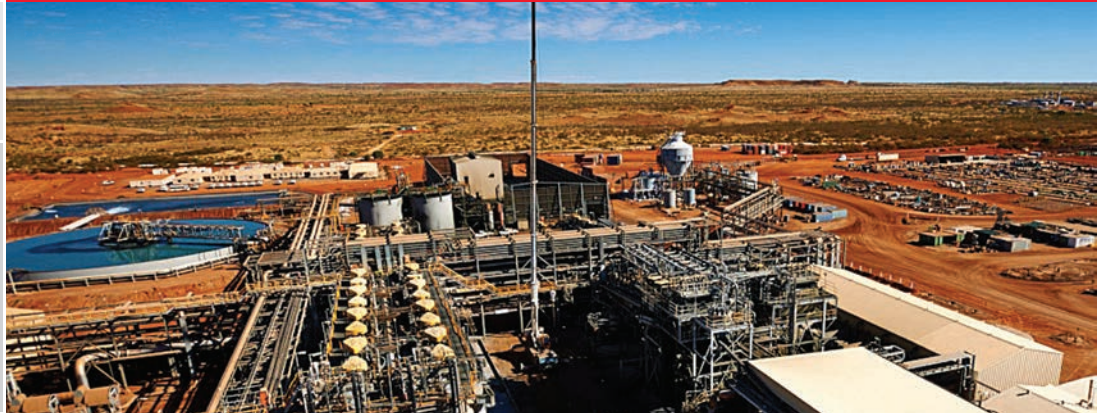
At one of the largest gold mines in Australia, acid used in the elution process had led to significant concrete erosion and steel corrosion.

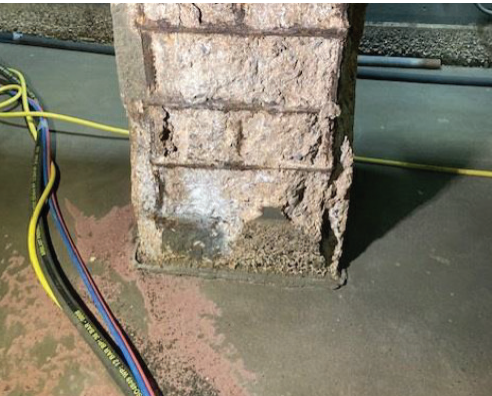
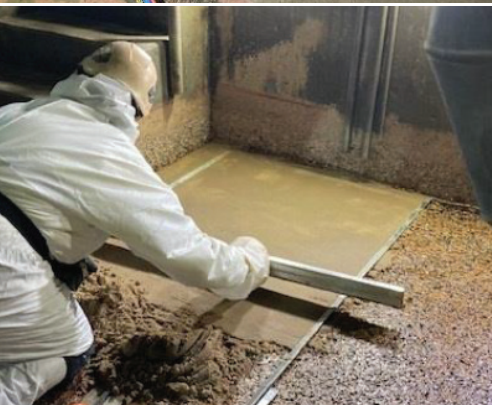
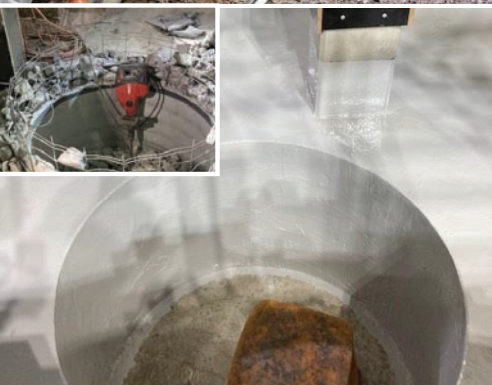
Solid sodium hydroxide is used in the gold elution process. Chemical attack meant 70% of the bund floor area needed to be removed and reinstated. The acid sump also needed to be broken back to good concrete and reinstated. Several plinths and steel reinforcements were damaged beyond repair.

This project involved significant surface preparation, including the removal of damaged concrete and any remaining membranes and polyurethanes. Drummy testing around the sump pit ensured all delaminated concrete was removed. The entire area was cleaned with compressed air before new key ways were cut to enable the repair mortar to bond to the existing floor. A final high pressure wash meant the floor was ready for screeding.

- Step 1:** Floor screed installed using Nitomortar 903 with Nitomortar F4 Fillers. This created a high strength epoxy mortar that hardened quickly.
- Step 2:** An extra coating of Nitomortar 903 was applied to seal the screed.
- Step 3:** Two coats of Nitocote EP410 were applied to the bund floor, bund sump and up stands.
- Step 4:** All new steel was coated with Nitoprime Zincrich. Existing steel was abrasive blast cleaned to Class 2.5.
- Step 5:** Vector Galvashield XP4 Anodes were connected to the steel-reinforced plinths.
- Step 6:** The plinths were formed, pre-soaked and then poured with Renderoc LA55.
- Step 7:** The bund sump walls were broken back to host concrete in good condition, then formed and poured with Renderoc LA55.
